## Release Notes for iCube Control Products

**Release 2026.6**

**Date: 2026-09-01**

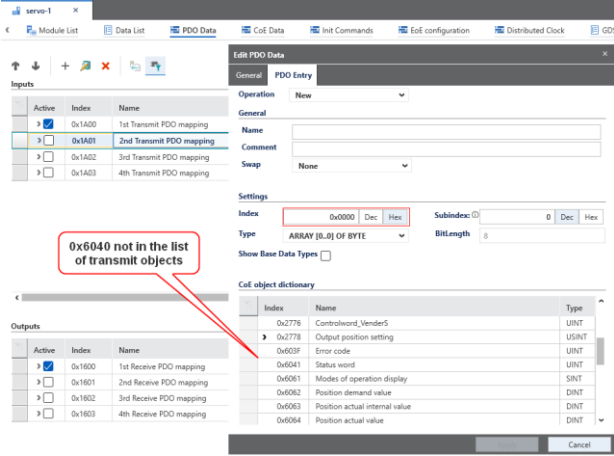
| ID | Title | Description | Resolution |
|---|---|---|---|
| 70347 | ESI File SigmaX: missing PDO mapping EtherCAT register to read the input Transmit Data (read from SubDevice) | <p>Some models of Sigma-X servos do not include the proper ESI file tags to use receive (R) objects as transmit (T) objects. For example, the control word (0x6040) can be used as both receive and transmit, but iCube Engineer doesn't list it in the transmit section.</p> <p>Disclaimer: An object missing from the transmit list doesn't automatically mean that it is because of this issue; it might simply be that that's the expected behavior.</p> | <p>This Defect has been fixed with catalog resource version (&gt;= 0x2000B). Please refer to the Workaround as an alternate path.</p> <p>Workaround for older servopacks: Do not map objects to the PDO that are not available in the servo's firmware version being used.</p> |

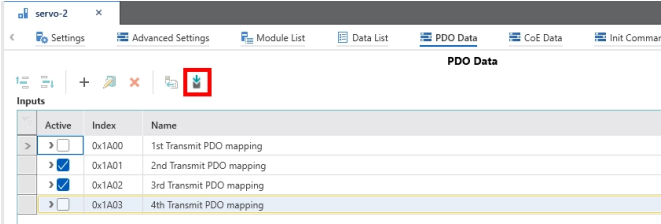
| 88136 | PDO Data: Init Commands page does not update after checking/unchecking "Create the init commands ..." button | <p>Init Commands page does not immediately update after checking/unchecking the "Create the init commands and download the PDO configuration during start-up" button.</p> | The defect is fixed. |

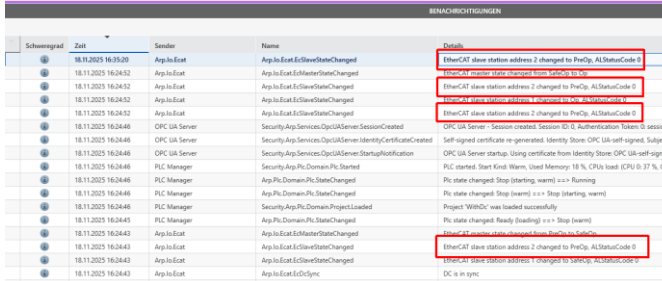
| ID | Title | Description | Resolution |
|---|---|---|---|
| 79385 | EtherCAT SubDevice state change notification does not report correct ALStatusCode | <p>In certain scenario, some EtherCAT sub devices fail to move to a desired state and the log message : "EtherCAT slave station address x changed to , ALStatusCode 0" appears several times on the same EtherCAT state</p> | Add new notification which reports the slave error together with ALStatusCode |

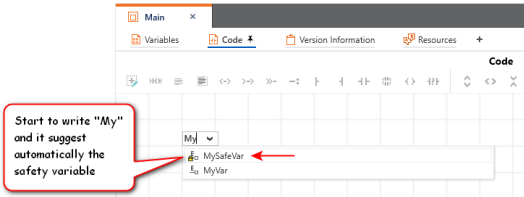
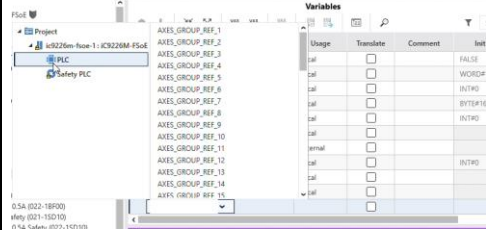
| ID | Title | Description | Workaround |
|---|---|---|---|
| 32554 | Safe variable aren't protected from the main PLC | <p>Names of variables from the Safety PLC project will appear in a list of available variables when working in the standard PLC project. This occurs when typing a variable name - see the example below - as well as when browsing the variable names in the drop-down list. If a safety PLC variable is used within the standard PLC project this will cause an error when the project is rebuilt.</p> <p>Start to write "My" and it suggest automatically the safety variable</p> | <p>When selecting a variable name, first open the variable list drop-down and then select "PLC" to filter only for standard PLC variables.</p> |

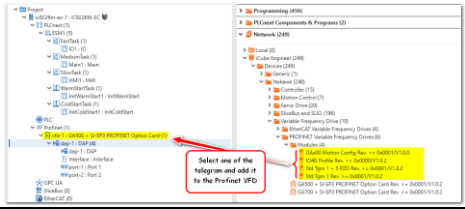
| ID | Title | Description | Workaround |
|---|---|---|---|
| 43636 | Drive scanned from the Profinet network doesn't automatically add the GAX00 Motion Config module | Executing a Profinet scan functionality on Yaskawa Profinet VFD doesn't add the Profinet telegram Part. | <p>there are 2 solutions:</p> <ul style="list-style-type: none"> <li>add the Profinet VFD from the catalog manually instead of automatically with the Profinet scan</li> <li>add manually Profinet telegram to the Profinet VFD after the scan has been executed:</li> </ul> |

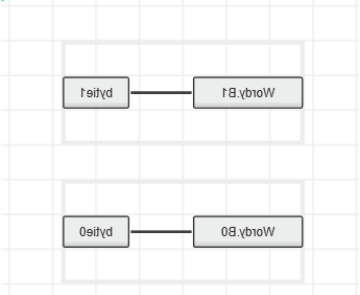
| ID | Title | Description | Workaround |
|---|---|---|---|
| 46312 | non safety FB from "Safety IEC 61131-3" library aren't supported on iC922xM-EC | If a WORD_TO_BYTES FB is used in the application, a compile error is generated mentioning that the iC922x resource does not support the WORD_TO_BYTES function block because this FB is part of the Safety IEC 61131-3 library. | <ul style="list-style-type: none"> <li>Do not use any FB from Safety IEC 61131-3 in a nonsafe PLC.</li> <li>Use implicit addressing as shown below:</li> </ul> |

| ID | Title | Description | Workaround |
|---|---|---|---|
| | | | <pre> 1 byte1 := wordy.B0; 2 byte2 := wordy.B1; 3 </pre> |

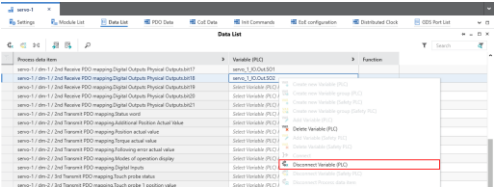
| ID | Title | Description | Workaround |
|---|---|---|---|
| 77587 | SGD7W: Incorrect output signal mapping leads to incorrect Y_AX_BrakeRelease execution | <p>Output signals SO2 and SO3 for an SGD7W SERVOPACK are not mapped to the expected axes, as defined in the SERVOPACK manual.</p> <p>SERVOPACK signals can be mapped to SO1 and/OR SO3 for Axis A, and to SO2 and/or SO4 for Axis B.</p> <p>This has for consequence to not open the brake while using Y_AX_BrakeRelease for the Axis B with SO2 (default value)</p> | <p>Find the mapping of SO2 and SO3, right-click on the variable row, and select "Disconnect Variable (PLC)".</p> <p>Map SO2 to bit 18 of the output of the second module, and SO3 to bit 19 of the first module. The result should look as follows:</p> <p>After this change, Y_AX_BrakeRelease can be used with SO2 as default value.</p> |

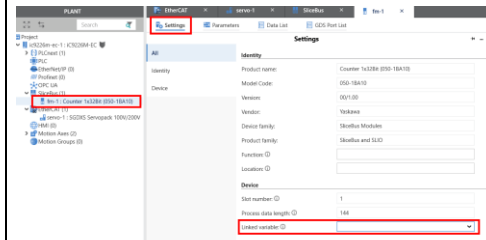
| ID | Title | Description | Workaround |
|---|---|---|---|
| 80638 | Downloading 2025.6 Project with 1BA10 counter module on slicebus or CoE bus coupler to 2026.0 iC9226 causes Exception upon download. | Downloading an iCube Engineer 2025.6 Project with 1BA10 slicebus counter module to an iC9226 with firmware 2026.0 causes exception upon download. The error message "PLC Failed: Exception occurred: The following connector configurations are faulty and cannot be established." is shown. | <p>Unlink the variable attached to the module's settings page.</p> |

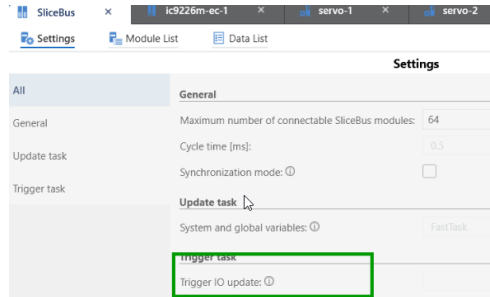
| ID | Title | Description | Workaround |
|---|---|---|---|
| 80833 | Exception (SliceBus related) when downloading project from iCube Engineer 2024.9.1 → iC9226M-EC v2026.0 | If a trigger task is set for projects containing slicebus configurations in 2024.9 are downloaded to an iC9200 with firmware 2026.0, a slicebus related PLC exception occurs. | <p>Unlink the task linked to the Trigger Task in the SliceBus Settings page.</p> |

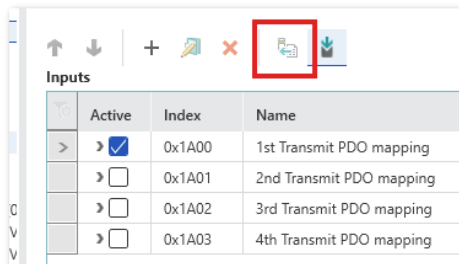
| ID | Title | Description | Workaround |
|---|---|---|---|
| 81577 | Unable to Load PDO Information from a Sigma-X slave | <p>The "Load PDO information from slave" button is unavailable for sigmaX drives. This fails on firmware versions 11 and 15.</p> | Configure the PDO manually. |

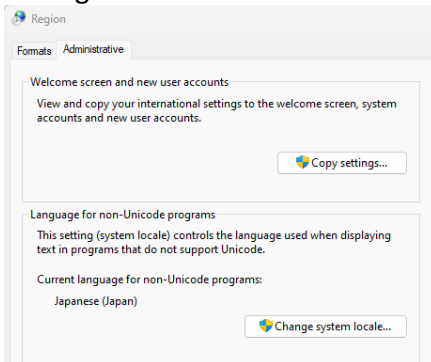
| ID | Title | Description | Workaround |
|---|---|---|---|
| 83257 | When the language setting is set to Japanese, garbled characters occur when exporting/importing PLC data lists | When the language setting is set to Japanese, garbled characters show up when exporting/importing PLC data lists. | <p>The problem can be resolved in the following way:</p> <ul style="list-style-type: none"> <li>• Check the non-unicode program setting is set to Japanese in windows settings.</li> </ul> |

| ID | Title | Description | Workaround |
|---|---|---|---|
| | | | <ul style="list-style-type: none"> <li>Check the Windows display setting is set to Japanese and the Japanese language pack is installed</li> </ul> <p>Use the following directions when editing the .csv file in Excel:</p> <p>---</p> <p>Note: The PnE generated CSV file is UTF-8 encoded!!!</p> <p>When importing a CSV file into Excel, the expected encoding depends on:</p> <ul style="list-style-type: none"> <li>Excel version</li> <li>Operating system locale</li> </ul> <p>How you open the file (double-click vs. using Import)</p> <p>1. Default Behavior</p> <p>Windows Excel (most versions):</p> <p>If you double-click a .csv file, <b>Excel assumes it is encoded in the system's default ANSI code page</b> (e.g., Windows-1252 for Western Europe, Shift-JIS for Japanese).</p> <p>→ This often causes UTF-8 characters (like ä, ö, ü, ß, é) to display incorrectly.</p> |

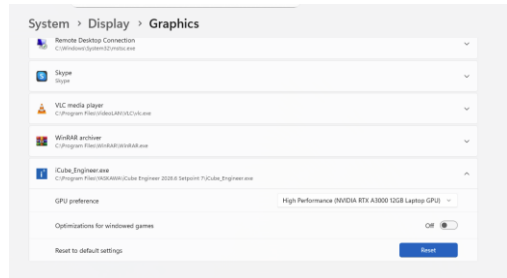
| ID | Title | Description | Workaround |
|---|---|---|---|
| 86622 | Cam Editor: ICE crashes on opening cam program | In some situations, depending on the user graphics settings, iCube Engineer can crash when the Cam Editor is opened. | Under System > Display > Graphics add the iCube application to the list of applications. For GPU preference select the computer's dedicated GPU. |

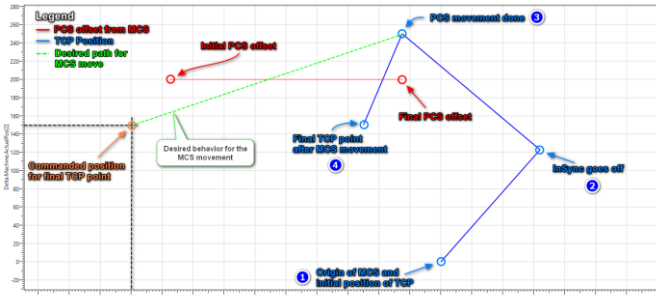
| ID | Title | Description | Workaround |
|---|---|---|---|
| 33337 | MC_TrackConveyorBelt: Wrong final position calculation for MCS move after PCS move that finishes after tracking | <p>When using MC_TrackConveyorBelt, sending a PCS move to the motion buffer that finishes <u>after the tracking</u> has concluded, followed by an MCS move, will result in an incorrect final MCS position (provided that the MCS move is sent to the motion buffer while the PCS is not done). See reference graph below.</p> | <ul style="list-style-type: none"> <li>Send the MCS move to the motion buffer only when the PCS move has been finished.</li> <li>Make sure that the PCS move finished before the MC_TrackConveyorBelt.InSync goes false.</li> </ul> |

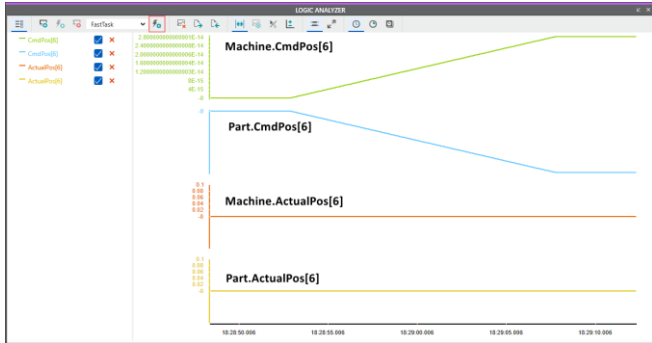
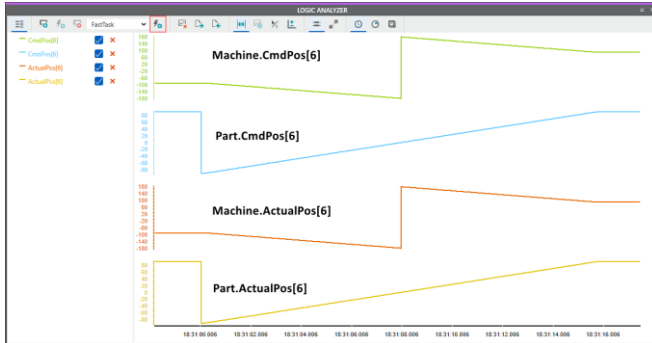
| ID | Title | Description | Workaround |
|---|---|---|---|
| 50808 | Motion Group: Problems with PCS handling for group's rotational axis defined as a linear load type | <p>If a group's rotational axis is defined as "Linear (finite)" in its configuration, the group will not handle said axis correctly when commanding trajectories using a PCS coordinate system. In such a case, multiturn rotations are not handled. For example, a rotation of 720° was commanded in the following image.</p> <p>Also, PCS movements where the rotational axis' position crosses 0 might cause a jump in the MCS position, as seen in the following image. The servo will throw an alarm in such a case, stopping the motion of the whole group.</p> | <p>Some possible workarounds are:</p> <ul style="list-style-type: none"> <li>• Do not use a PCS coordinate system</li> <li>• Select target positions that avoid conflicting trajectories</li> <li>• Add middle positions commanded in MCS to avoid conflicting trajectories</li> </ul> |
