# Release Notes for iCube Control Products

Release 2025.6

Date: 2025-09-04

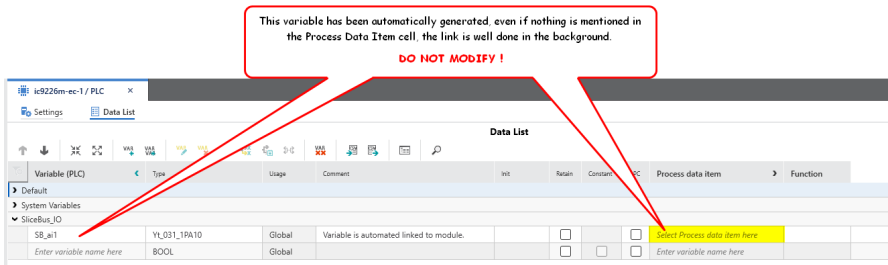
| ID | Title | Description |
|---|---|---|
| 49241 | Automatic IO Variable generation : PDIs links to PLC variables are not displayed in the data list | <p>The automatically generated variable may not have a Process Data Item linked to it. The link is made automatically by iCube Engineer automatically in the background. If the user map a PDI, this will overwrite this automatic link done by iCube Engineer.</p> |

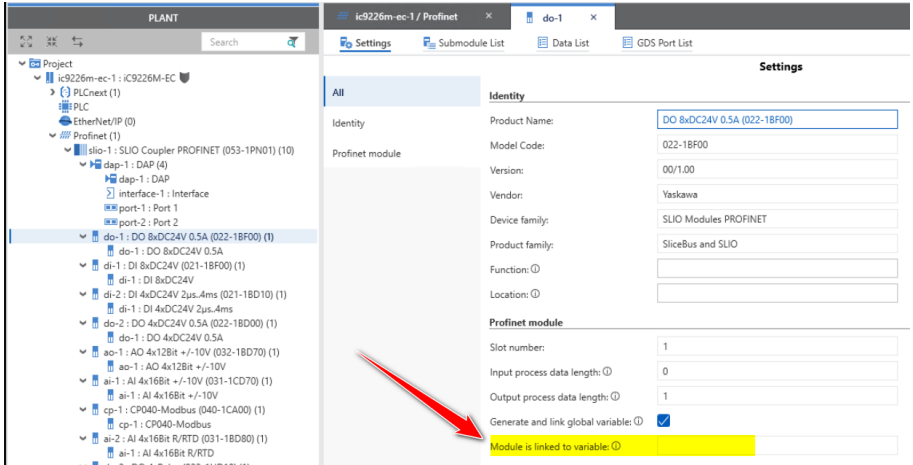
| 56985 | Profinet device integrated via "Online-Devices" has no name for automatically integrated variables | <p>Using the "Online-Device" option to scan Profinet coupler with SLIO module and then use the button "Add to project" create a module with the "Generate link global variable" checkbox checked but no variable linked to it :</p> |

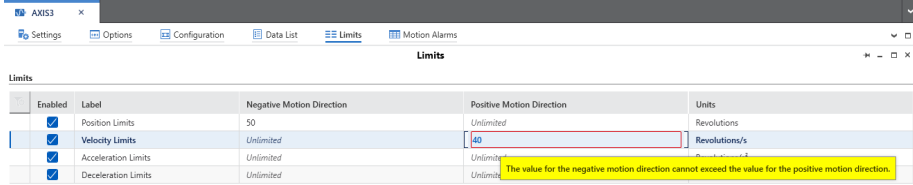
| 57944 | Motion Axes: ServoNet positive Velocity limits is compared to the wrong value | <p>When using motion axes, if the values to be used for velocity, acceleration, and deceleration limits in the positive motion direction are lower than the position limit in the negative motion direction, the software will not allow the setting of said value (see reference image)</p> |

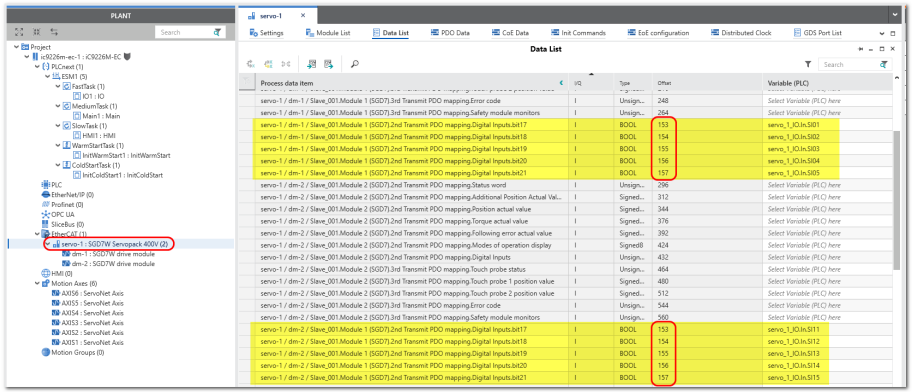
| 60264 | Offset of EtherCAT slave process datum not updated | <p>Some module devices have wrong Offset information display, for example Sigma7W:</p> |

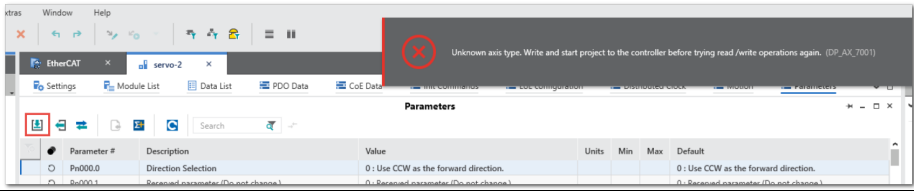
| 60362 | "Unknown axis type" error message when writing parameters to Servopack if faulty network address | <p>The message "<i>Unknown axis type. Write and start project to the controller before trying read /write operations again.</i>" will show up if the user tries to Read or Write from/to a SERVOPACK while there is a network identification issue:</p> |

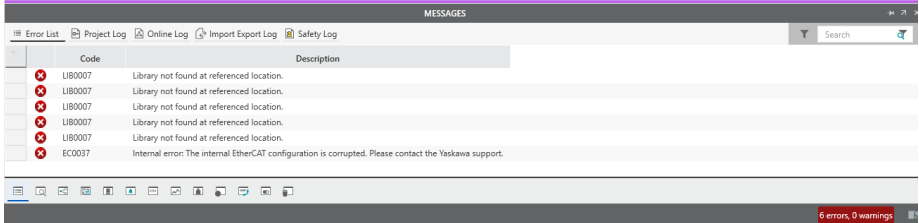
| 65133 | The path of directory does not update in the iCube when installed by choosing a different destination for user data | <p>If the default installation path has been changed during the installation process, the user will experience the following error when creating a project from template:</p> |

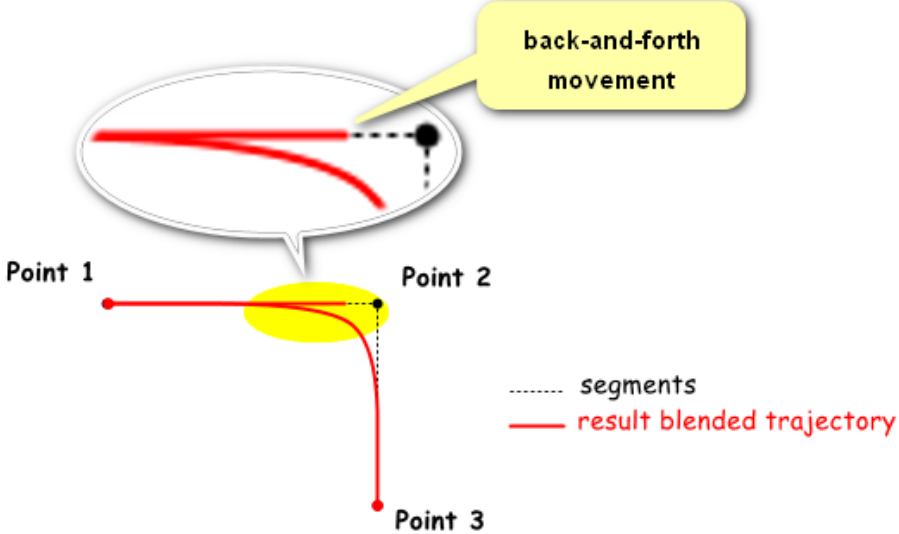
| 58494 | Unexpected back-and-forth movement when blending with MC_MoveLinearAbsolute, when MC_BufferMode#Aborting is used in actually buffered scenarios | <p>PLCopen Part 4 multi-axis motion (MC_MoveLinearRelative, MC_MoveLinearAbsolute) blending between two consecutive moves can follow an unexpected trajectory for the first part of the move, including a sudden change in velocity.</p> <p>This occurs only when the first move in a multi-move sequence is specified with MC_BufferMode#Aborting input (which is the default), followed by MC_BufferMode#BlendingXXXX.</p> <p>The motion produces a back-and-forth movement between the 2 first segments during the blending transition as follows:</p> <p>Notes:</p> <ul style="list-style-type: none"> <li>In this scenario, MC_BufferMode#Aborting is equivalent to MC_BufferMode#Buffered, because there is no in-progress move to abort.</li> <li>In general, if a MC_MoveLinearXXX with MC_BufferMode#Aborting <u>does</u> cause an in-progress move to abort, a following move with MC_BufferMode#BlendingXXX is not supported (an error will result). A full stop is required before the next move is possible.</li> </ul> |

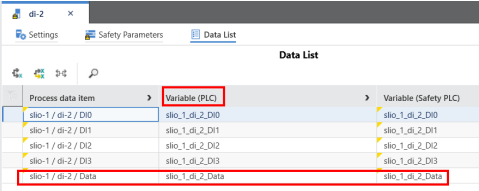
| ID | Title | Description | Workaround |
|---|---|---|---|
| 46400 | GDS-Error, when connecting the data variable of an FSOE-module with a non-safety plc variable - this variable connection is not undo-able | <p>If the 'Data' Process Data Item of a safety module is connected to a PLC variable as shown below, the project cannot be downloaded. The Data PDI should not be edited by the user.</p> | <ul style="list-style-type: none"> <li>Do not edit the Data PDIs for safety modules.</li> <li>Contact your Yaskawa support and provide the reference #46400</li> </ul> |

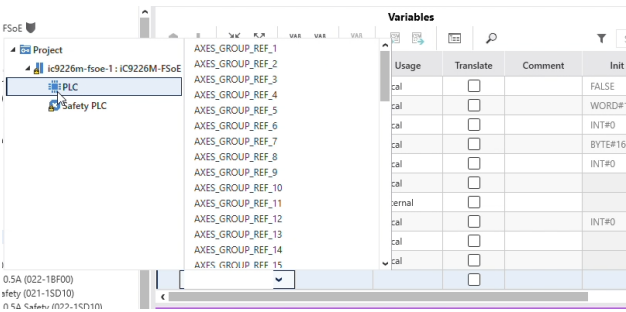
| 32554 | Safe variable aren't protected from the main PLC | <p>Names of variables from the Safety PLC project will appear in a list of available variables when working in the standard PLC project. This occurs when typing a variable name - see the example below - as well as when browsing the variable names in the drop-down list. If a safety PLC variable is used within the standard PLC project this will cause an error when the project is rebuilt.</p> | <p>When selecting a variable name, first open the variable list drop-down and then select "PLC" to filter only for standard PLC variables.</p> |

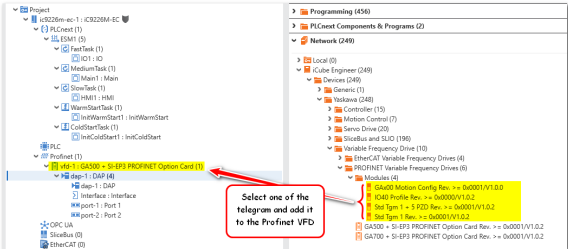
| 43636 | Drive scanned from the Profinet network doesn't automatically add the GAX00 Motion Config module | <p>Executing a Profinet scan functionality on Yaskawa Profinet VFD doesn't add the Profinet telegram Part.</p> | <p>there are 2 solutions:</p> <ul style="list-style-type: none"><li>• add the Profinet VFD from the catalog manually instead of automatically with the Profinet scan</li><li>• add manually Profinet telegram to the Profinet VFD after the scan has been executed:</li></ul> |

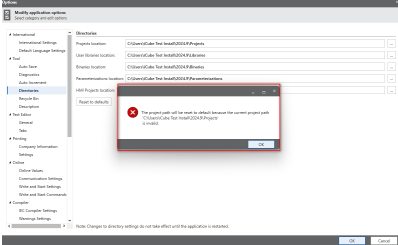
| 65179 | iCube Engineer Crash: when iCube Engineer folders (library, EtherCAT ...) are defined in a location that require Administrator rights | <p>If a directory path that requires Administrator rights is selected during iCube Engineer installation, and the current user does not have Administrator rights, then while updating the paths using Options-&gt;Extra, the following dialog will display and then iCube Engineer will crash.</p> | During iCube Engineer installation and directory selection in Options->Extra, only choose a directory path with full access permissions for the logged in user. |

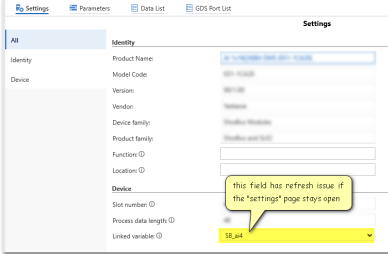
| 66544 | No refresh of dynamic combobox in settings editor | <p>After modifying the name of variable linked to a device in the "settings" page (either by changing the "function/location name and refactoring or just changing the variable name in the PLC table), the combo box in the setting page is not updated automatically.</p> | <p>This is an update/refresh issue of the settings page. To solve this issue leave the Settings page of the device and come back again. Now the display of the linked variable should be corrected.</p> |

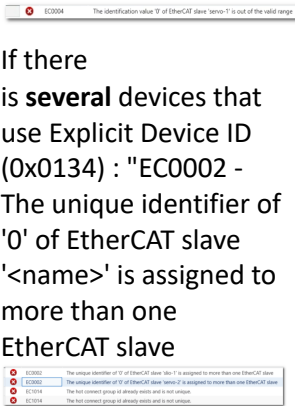
| 67564 | EtherCAT Bus Scan Does Not Properly Populate Identification Value and HC ID | <p>In iCube Engineer 2025.6, the EtherCAT bus scan will automatically recognize the identification value for devices that have the default identification "Station Alias (0x0012)" (e.g. Sigma7 servopacks) BUT will <b>not</b> recognize the identification value for devices that have the default identification "Explicit Device ID (0x0134)" (e.g. SigmaX servopack or EtherCAT bus coupler 053-1EC01), this will fill the identification value 0 and generate the following compilation error :</p> <ul style="list-style-type: none"> <li>• If there is <b>only one</b> device that use Explicit Device ID (0x0134) : "EC0004 - The identification value '0' of EtherCAT slave 'name' is out of the valid range"</li> <li>• If there is <b>several</b> devices that use Explicit Device ID (0x0134) : "EC0002 - The unique identifier of '0' of EtherCAT slave 'name' is assigned to more than one EtherCAT slave"</li> </ul> | Enter manually the correct identification value of the devices with the compile error. |

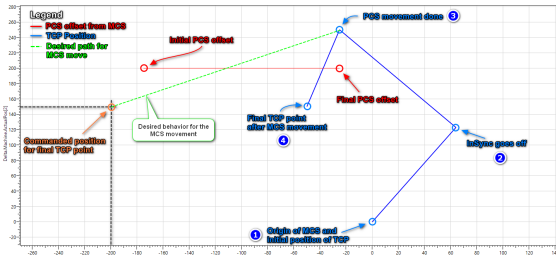
| 33337 | MC_TrackConveyorBelt: Wrong final position calculation for MCS move after PCS move that finishes after tracking | <p>When using MC_TrackConveyorBelt, sending a PCS move to the motion buffer that finishes <u>after the tracking</u> has concluded, followed by an MCS move, will result in an incorrect final MCS position (provided that the MCS move is sent to the motion buffer while the PCS is not done). See reference graph below.</p> | <ul style="list-style-type: none"> <li>• Send the MCS move to the motion buffer only when the PCS move has been finished.</li> <li>• Make sure that the PCS move finished before the MC_TrackConveyorBelt.InSync goes false.</li> </ul> |

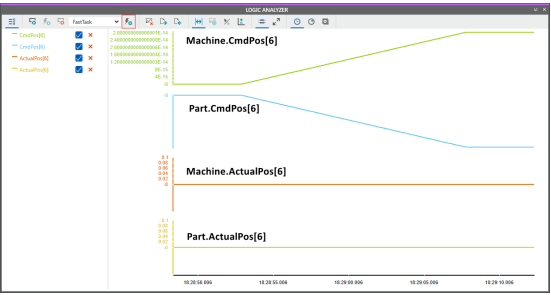
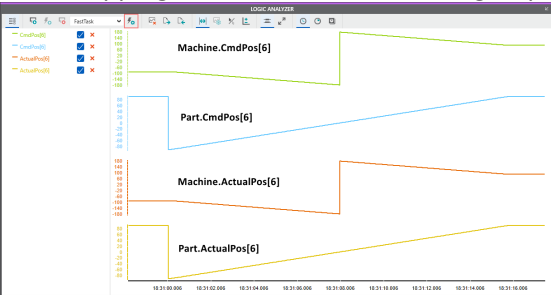
| 50808 | Problems with PCS handling for group's rotational axis defined as a linear load type | <p>If a group's rotational axis is defined as "Linear (finite)" in its configuration, the group will not handle said axis correctly when commanding trajectories using a PCS coordinate system. In such a case, multiturn rotations are not handled. For example, a rotation of 720° was commanded in the following image.</p> <p>Also, PCS movements where the rotational axis' position crosses 0 might cause a jump in the MCS position, as seen in the following image. The servo will throw an alarm in such a case, stopping the motion of the whole group.</p> | <p>Some possible workarounds are:</p> <ul style="list-style-type: none"> <li>• Do not use a PCS coordinate system</li> <li>• Select target positions that avoid conflicting trajectories</li> <li>• Add middle positions commanded in MCS to avoid conflicting trajectories</li> </ul> |
