Release Notes for iCube Control Products

Release 2025.6

Date: 2026-02-02

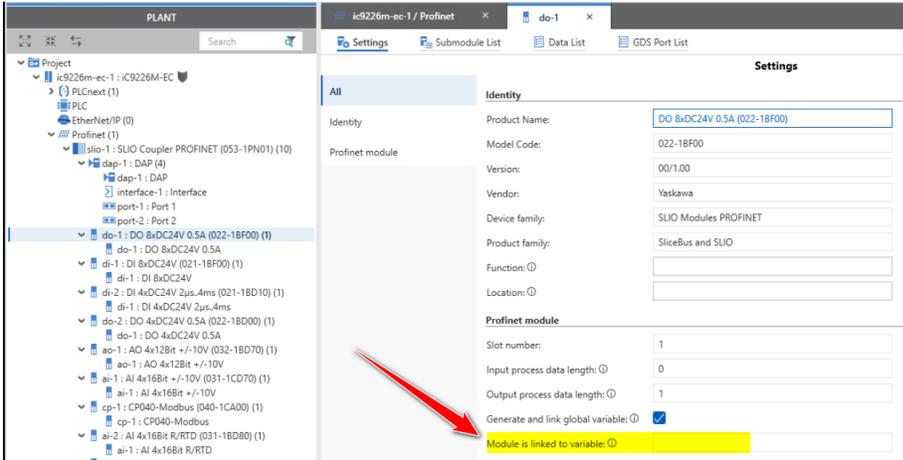
56985	Profinet device integrated via "Online-Devices" has no name for automatically integrated variables	<p>Using the "Online-Device" option to scan Profinet couplelr with SLIO module and then use the button "Add to project" create a module with the "Generate link global variable" checkbox checked but no variable linked to it :</p>

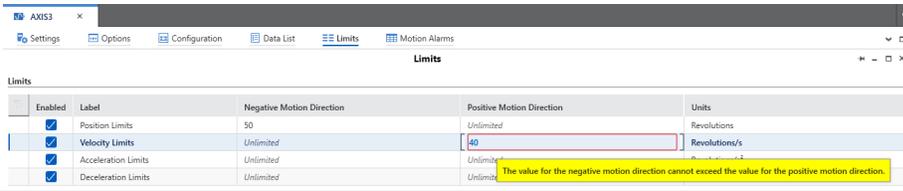
57944	Motion Axes: ServoNet positive Velocity limits is compared to the wrong value	<p>When using motion axes, if the values to be used for velocity, acceleration, and deceleration limits in the positive motion direction are lower than the position limit in the negative motion direction, the software will not allow the setting of said value (see reference image)</p>

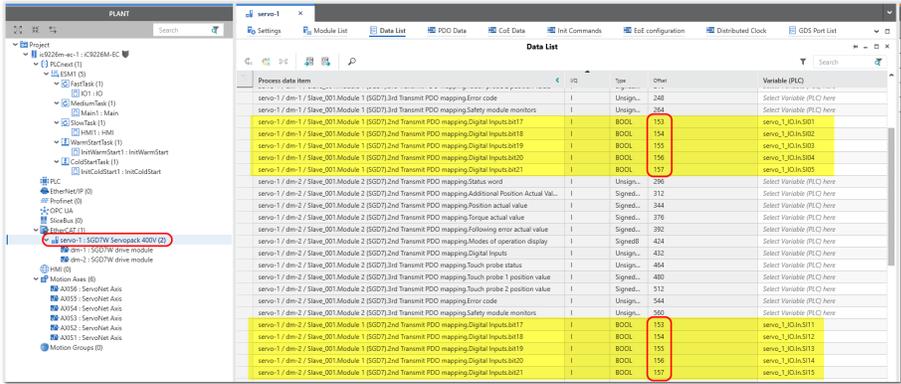
60264	Offset of EtherCAT slave process datum not updated	<p>Some module devices have wrong Offset information display, for example Sigma7W:</p>

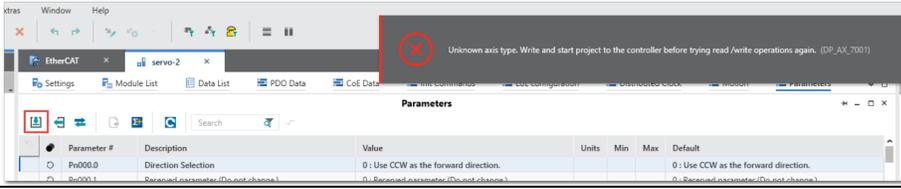
60362	"Unknown axis type" error message when writing parameters to Servopack if faulty network address	<p>The message "Unknown axis type. Write and start project to the controller before trying read /write operations again." will show up if the user tries to Read or Write from/to a SERVOPACK while there is a network identification issue:</p>

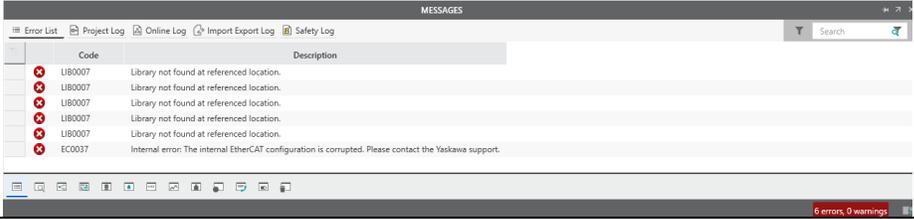
65086	EOE IP address error occurs when the controller IP address is changed, even though EOE is not active	If the IP address of the controller is changed, in the controller setting page, in a project where EtherCAT sub devices are present, EoE IP address errors can occur.
65133	The path of directory does not update in the iCube when installed by choosing a different destination for user data	If the default installation path has been changed during the installation process, the user will experience the following error when creating a project from template:

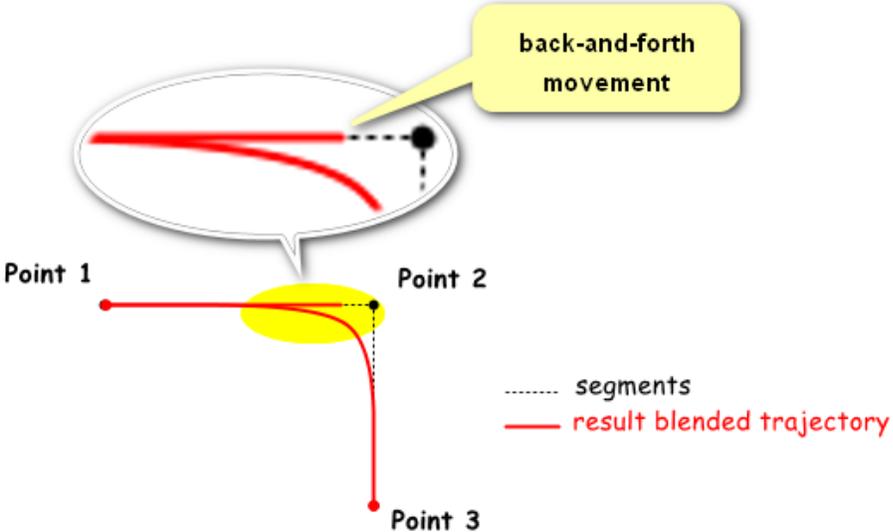
58494	Unexpected back-and-forth movement when blending with MC_MoveLinearAbsolute, when MC_BufferMode#Aborting is used in actually buffered scenarios	<p>PLCopen Part 4 multi-axis motion (MC_MoveLinearRelative, MC_MoveLinearAbsolute) blending between two consecutive moves can follow an unexpected trajectory for the first part of the move, including a sudden change in velocity.</p> <p>This occurs only when the first move in a multi-move sequence is specified with MC_BufferMode#Aborting input (which is the default), followed by MC_BufferMode#BlendingXXXX.</p> <p>The motion produces a back-and-forth movement between the 2 first segments during the blending transition as follows:</p>

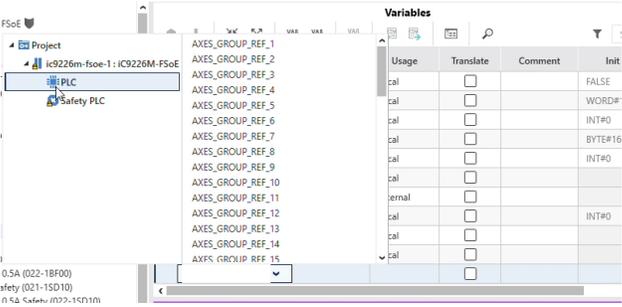
32554	Safe variable aren't protected from the main PLC	<p>Names of variables from the Safety PLC project will appear in a list of available variables when working in the standard PLC project. This occurs when typing a variable name - see the example below - as well as when browsing the variable names in the drop-down list. If a safety PLC variable is used within the standard PLC project this will cause an error when the project is rebuilt.</p>

<p>When selecting a variable name, first open the variable list drop-down and then select "PLC" to filter only for standard PLC variables.</p>

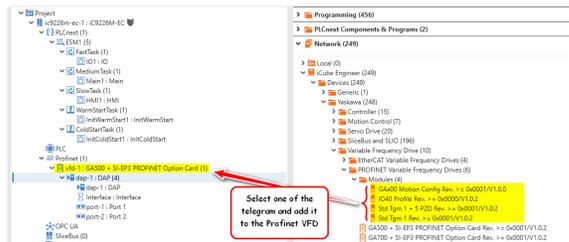
43636	Drive scanned from the Profinet network doesn't automatically add the GAX00 Motion Config module	Executing a Profinet scan functionality on Yaskawa Profinet VFD doesn't add the Profinet telegram Part.	<p>there are 2 solutions:</p> <ul style="list-style-type: none"> • add the Profinet VFD from the catalog manually instead of automatically with the Profinet scan • add manually Profinet telegram to the Profinet VFD after the scan has been executed:

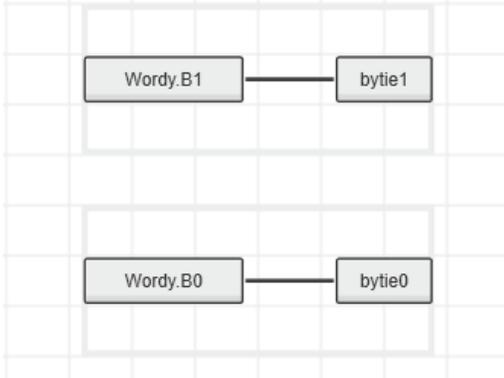
46312	non safety FB from "Safety IEC 61131-3" library aren't supported on iC922xM-EC	If a WORD_TO_BYTES FB is used in the application, a compile error is generated mentioning that the iC922x resource does not support the WORD_TO_BYTES function block because this FB is part of the Safety IEC 61131-3 library.	<ul style="list-style-type: none"> • Do not use any FB from Safety IEC 61131-3 in a nonsafe PLC. • Use implicit addressing as shown below:

<pre> 1 byte1 := wordy.B0; 2 byte2 := wordy.B1; 3 </pre>
-------	--	---	--

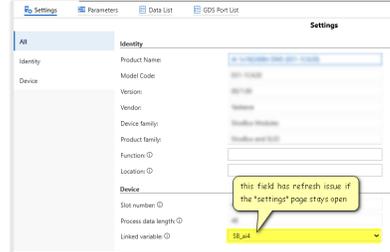
No refresh of dynamic combobox in settings editor

After modifying the name of variable linked to a device in the "settings" page (either by changing the "function/location name and refactoring or just changing the variable name in the PLC table), the combo box in the setting page is not updated automatically.

This is an update/refresh issue of the settings page. To solve this issue leave the Settings page of the device and come back again. Now the display of the linked variable should be corrected.

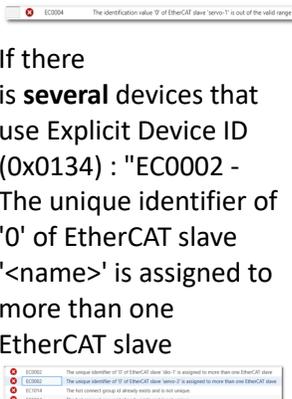
67564	EtherCAT Bus Scan Does Not Properly Populate Identification Value and HC ID	<p>In iCube Engineer 2025.6, the EtherCAT bus scan will automatically recognize the identification value for devices that have the default identification "Station Alias (0x0012)" (e.g. Sigma7 servopacks) BUT will not recognize the identification value for devices that have the default identification "Explicit Device ID (0x0134)" (e.g. SigmaX servopack or EtherCAT bus coupler 053-1EC01), this will fill the identification value 0 and generate the following compilation error :</p> <ul style="list-style-type: none"> • If there is only one device that use Explicit Device ID (0x0134) : "EC0004 - The identification value '0' of the EtherCAT slave '<name>' is out of the valid range" • If there is several devices that use Explicit Device ID (0x0134) : "EC0002 - The unique identifier of '0' of EtherCAT slave '<name>' is assigned to more than one EtherCAT slave"

Enter manually the correct identification value of the devices with the compile error.

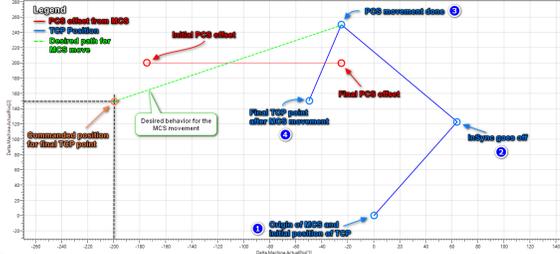
33337	MC_TrackConveyor Belt: Wrong final position calculation for MCS move after PCS move that finishes after tracking	<p>When using MC_TrackConveyorBelt, sending a PCS move to the motion buffer that finishes <u>after the tracking</u> has concluded, followed by an MCS move, will result in an incorrect final MCS position (provided that the MCS move is sent to the motion buffer while the PCS is not done). See reference graph below.</p>

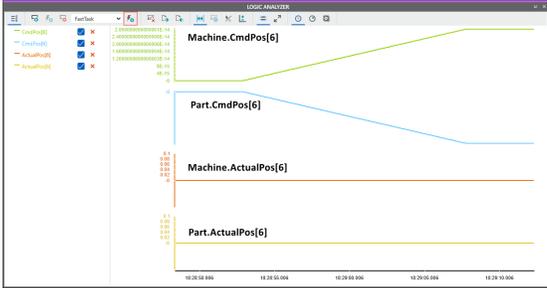
50808	Problems with PCS handling for group's rotational axis defined as a linear load type	<p>If a group's rotational axis is defined as "Linear (finite)" in its configuration, the group will not handle said axis correctly when commanding trajectories using a PCS coordinate system. In such a case, multiturn rotations are not handled. For example, a rotation of 720° was commanded in the following image.</p>

<p>Some possible workarounds are:</p> <ul style="list-style-type: none"> • Do not use a PCS coordinate system • Select target positions that avoid conflicting trajectories • Add middle positions commanded in MCS to avoid conflicting trajectories
53109	SI-EP3 PROFINET Option Card for VFD: No information about STO inside Status Word available	<p>In the Statusword of SI-EP3 PROFINET option card there is no information about STO (Safe Torque Off) inside the Status Word.</p> <p>Therefore there is no reaction possible with the MC Function blocks (e.g. MC_MoveVelocity, MC_ReadStatus) in case of STO</p>	<p>Using the Multiprotocol Card JOHB-SMP3 (PROFINET mode) there is the STO information in Status Word Bit 14.</p> <p>Control/Status has to be set on 1: Yaskawa P-Drive</p>

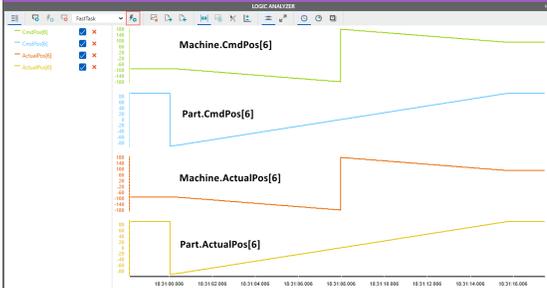
<p>Also, PCS movements where the rotational axis' position crosses 0 might cause a jump in the MCS position, as seen in the following image. The servo will throw an alarm in such a case, stopping the motion of the whole group.</p>

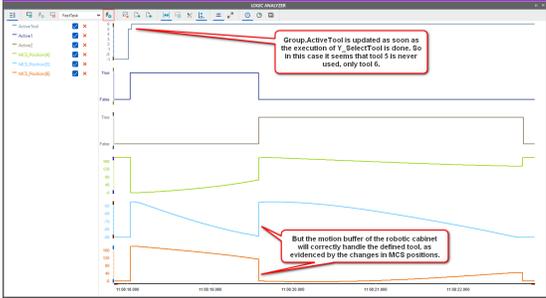
66002	MotomanSync: Group.ActiveTool is not representative of the tool the group is using in all cases	<p>For MotomanSync groups, queuing several moves in the motion queue in advance using a BufferMode different than Aborting with different tools (<i>using Y_SelectTool in between moves</i>) will perform correctly, but the signal Group.ActiveTool will be updated when Y_SelectTool's execution is done and not when the move tool is active.</p>

The tool handling is correctly handled for the motion part, but to get the correct ActiveTool information, the user has to write their own logic using the "Active" output signal of each move function block and update a customized "ActiveTool" variable accordingly.
69803	Delta3/Delta5 unable to recover via MC_GroupReset after exceeding rMin/rMax limits	For a Delta-3 or Delta-5 axes group, if the central shaft limits rMin/rMax are exceeded (usually by means of an ACS move), then when an MCS move is attempted, the axes group will enter an alarm state which cannot be recovered using MC_GroupReset.	<ol style="list-style-type: none"> 1. Disable the group via MC_GroupDisable 2. Use individual AXIS_REF moves via MC_MoveAbsolute to home the axes to a known good state 3. Enable the group via MC_GroupEnable 4. Clear the error condition via MC_GroupReset
