Release Notes for iCube Control Products

Release 2025.6

Date: 2025-12-18

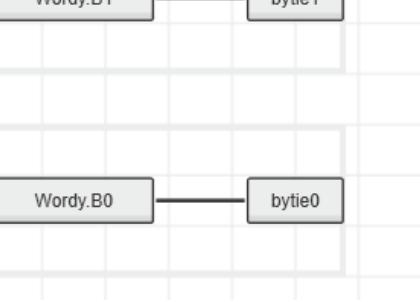
46312	<p>non safety FB from "Safety IEC 61131-3" library aren't supported on iC922xM-EC</p>	<p>If a WORD_TO_BYTES FB is used in the application, a compile error is generated mentioning that the iC922x resource does not support the WORD_TO_BYTES function block because this FB is part of the Safety IEC 61131-3 library.</p>	<ul style="list-style-type: none"> • Do not use any FB from Safety IEC 61131-3 in a nonsafe PLC. • Use implicit addressing as shown below:

<pre> 1 byte1 := wordy.B0; 2 byte2 := wordy.B1; 3 </pre>
